Lacquering / Black spots on cylinder liner

This service information covers the technical explanation for formation of lacquering on the cylinder liner, and how to deal with this condition.

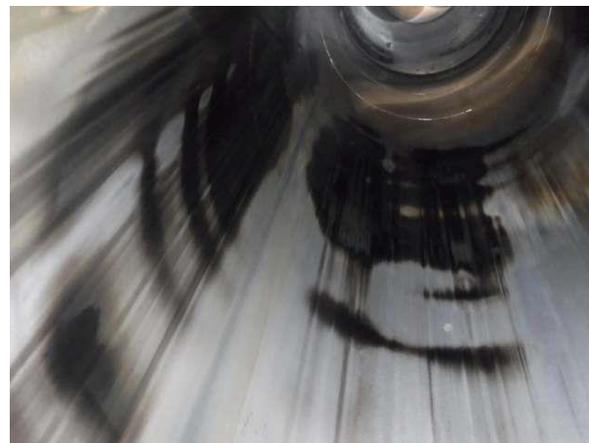
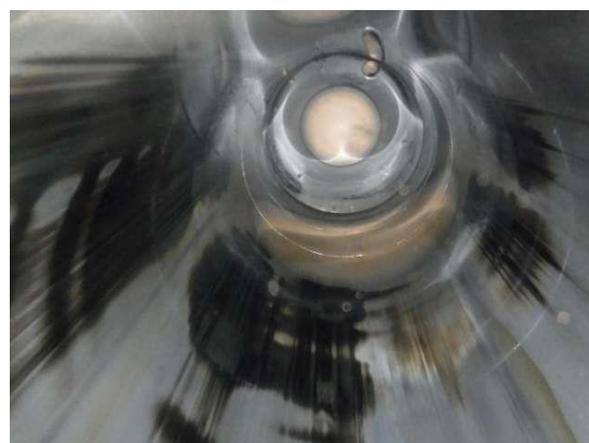
Examples of Lacquering / Black spots

Signs of lacquering / black spots on cylinder liner walls

Lacquering occurs on areas of the cylinder wall, which at a previous point has been exposed to additional corrosive wear causing the area to be slightly retracted from the running surface which is in contact with the piston rings. This situation causes that deposits can build up on the slightly retracted area, as this area is exposed to less wear as compared to the remaining area.

The deposits forming on the slightly retracted areas of the cylinder originate from a chemical reaction during the combustion between additives from the cylinder oil, the Sulphur content of the fuel oil and the humidity from the scavenge air. This is also the reason why lacquering is more prone to occur on vessels operating in tropical areas where air humidity is higher.

The chemical reaction causes deposits of Calcium Sulphate and combustion residues to form in the retracted areas. The dark or black colors of the spots originate from soot and other combustion residues. Lacquering is a condition which can occur regularly and is removed by detergents from the cylinder oil and normal wear.

Experience has shown that normal cylinder condition is maintained despite the presence of black spots. Lacquering is a fully harmless symptom which in general has no negative effect on the operational condition of the engine, and there is therefore no problem in continuing engine operation despite the presence of black spots.

We recommend disregarding the presence of black spots when evaluating the cylinder condition, and determine the cylinder oil feed rate based on other parameters such as piston and piston ring condition as well as analysis of scrape down oil.

It is a common misconception that the cylinder oil feed rate must be increased as a countermeasure to deal with the condition. This is not recommended, as this may result in over lubrication, causing compromised cylinder condition.
